Lightened collision mat

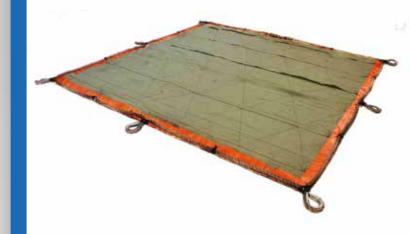
The lightened collision mat, made of a fiber felt 10-12 mm thick, is used for temporary repair works of large hull breaches. The backbone of the mat is fiber felt 10-12 mm thick, covered on both sides with a special boiled sea canvas with waterproof impregnation. The stiffness is created by strain frames 2.8 x 20.0 mm.

The frames of the mat should be arranged horizontally they prevent the mat from being pressed into the hull

· Size - 3.0 x 3.0 m (Canvas layers -2 pcs,; Interlayer - 1 felt padding)
